**MACINTYRE REALTIES**

APPRAISAL REPORT

of the buildings and other structures  
located on the property of the  
Gatineau Yacht Club.

This property being two islands in  
the Gatineau River at Gleneagle,  
West Hull, Quebec.

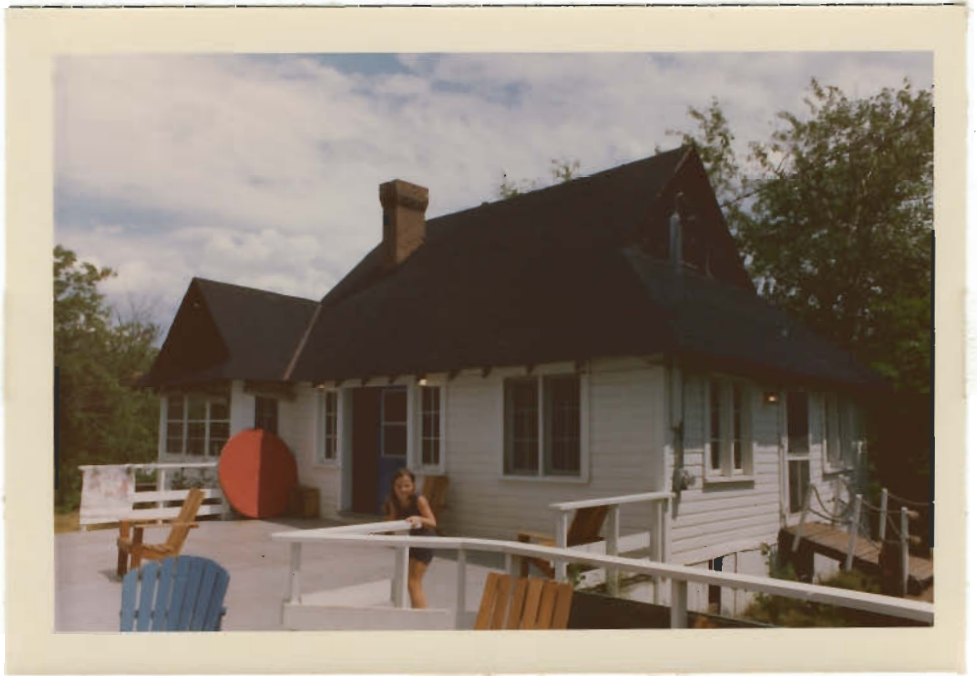
Front of club house from the western corner of the porch.

The Club House as seen on pages 3, 4 and 5 is basically a 40 year old cottage. It is a standard frame cottage with white pine siding, black trim, asphalt shingle roof and enclosed foundation. It is supported by rocks, blocks and posts to bed-rock. Interior bedroom walls have been removed in order to make one large room. The ceiling and roof are now supported by a central post and beams which were installed to replace the function of the bearing walls. This main room is 24' x 24', has plywood walls and ceiling, a painted pine floor and a brick fireplace

The property has been maintained in fairly good condition.

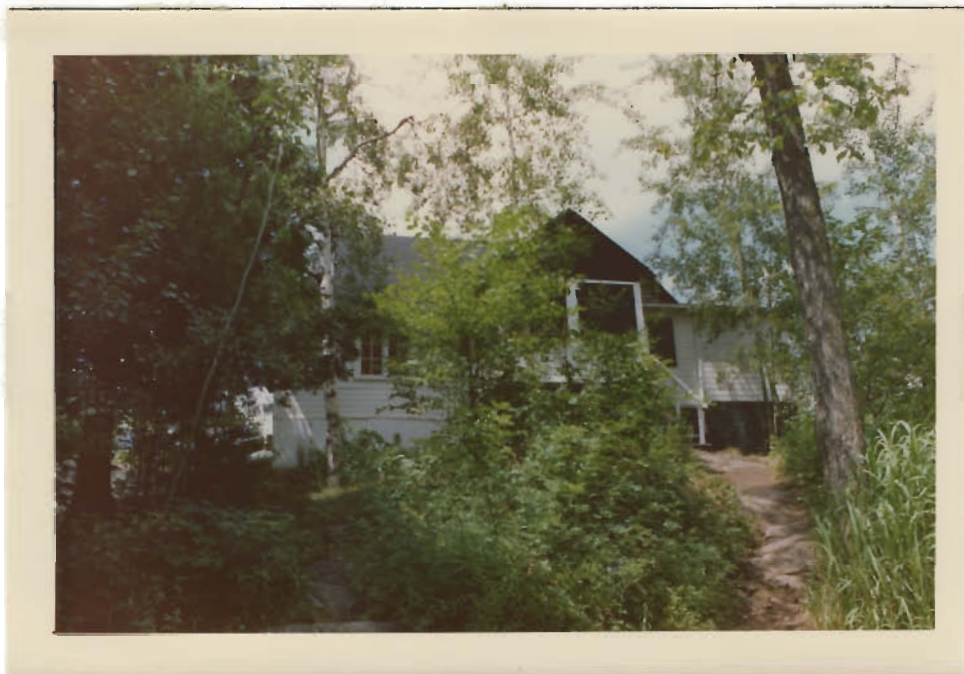
Back of club house as seen from cleared area from end of boom.

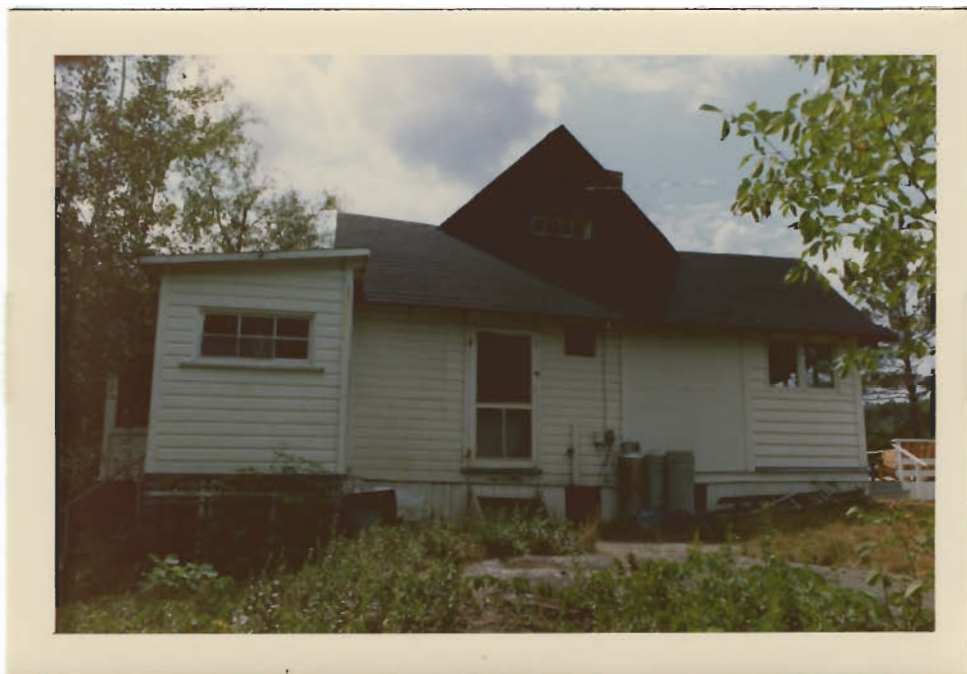
North East side of club house showing rear entrance to kitchen.

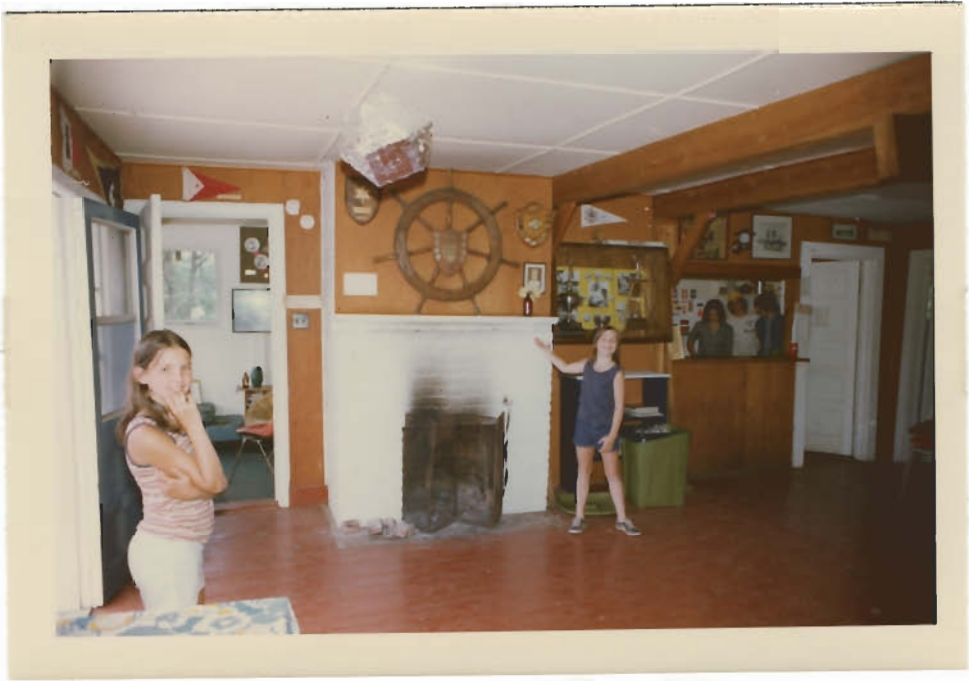
Main room of club house with front door on left, office to left of fireplace and kitchen to right of fire place.

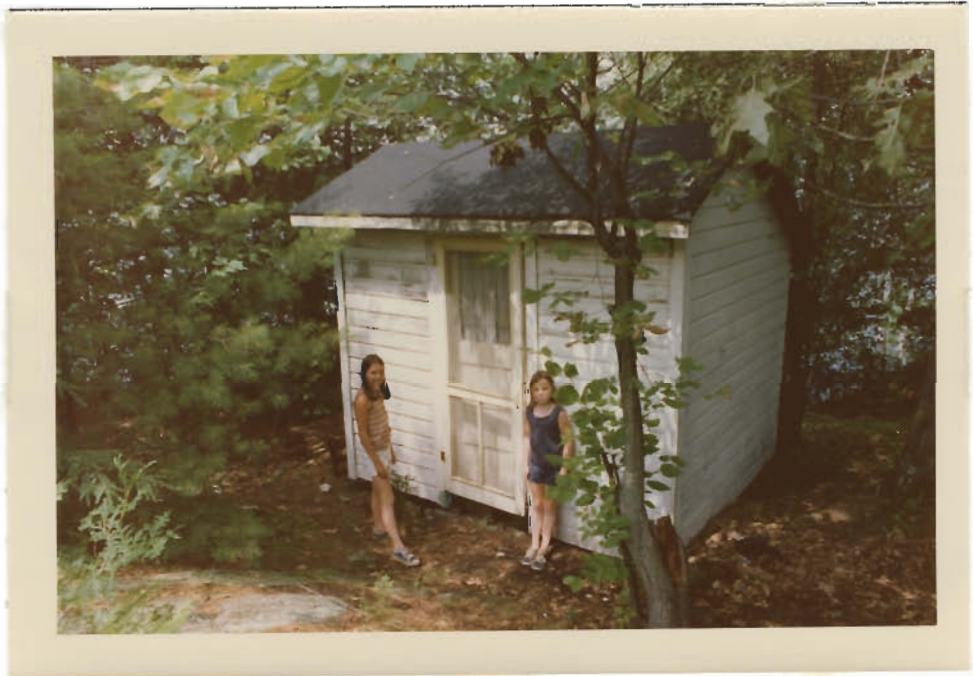
Managers office just east of club house.

The office, being a separate 10'4" x 8'4" building has a floor area of 85 sq.ft. It is a very elementary unlined, featheredge cabin with rolled roofing and an electrical connection to the Main Lodge. Its Reproduction Value would be..... \$ 700.00 Its Depreciated Value is approximately ..... \$ 400.00

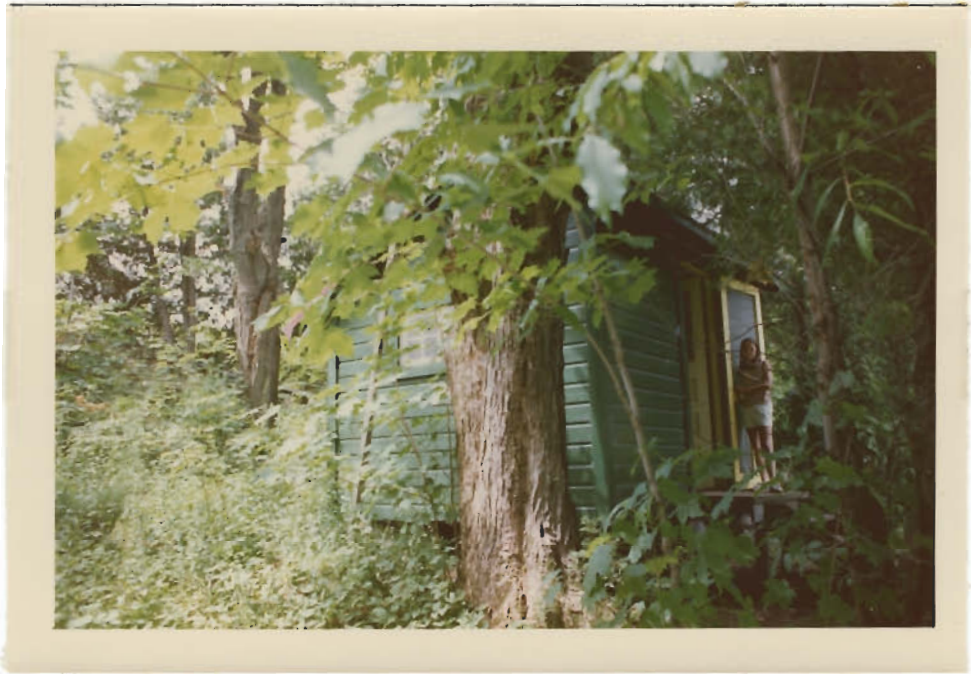
Girls changing house.

This building, as seen at the top of page 6, has a floor area of 116 sq.ft. and has a Replacement Value of approximately..... \$ 1,100.00  
It is considered to be about 30% Depreciated so that its present value is approximately..... \$ 750.00

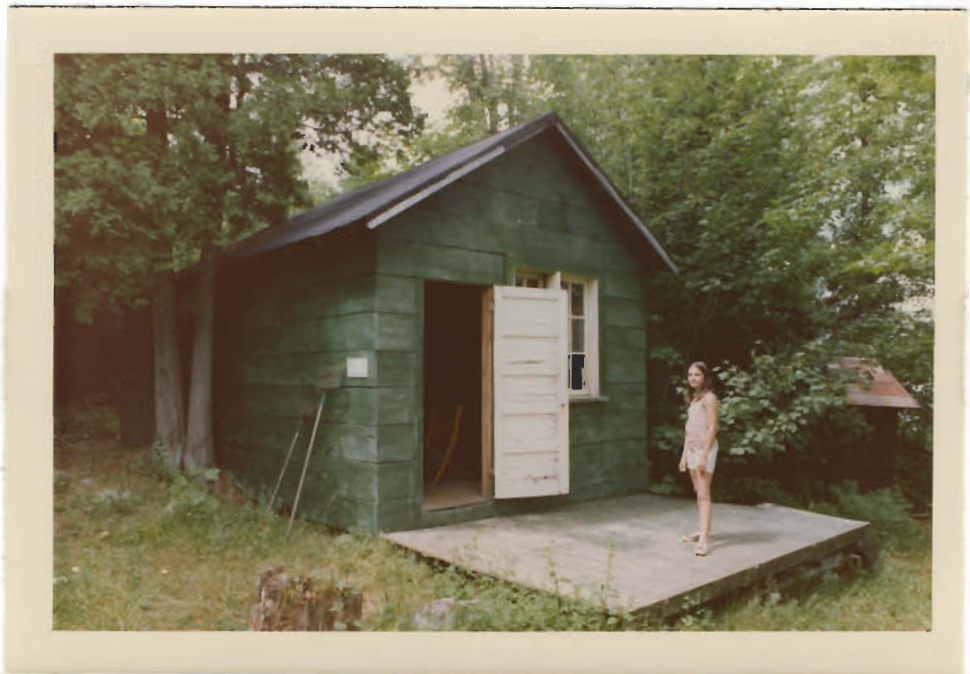
Boys changing house.

This building, as seen at the bottom of page 6, is 12'2" x 16' and has a floor area of 196 sq.ft. It is constructed of plank walls, a rolled roofing cover and has an 8' x 12' open deck in front. There is a toilet and basin in one corner. The Replacement Value of this building is approximately..... \$ 1,800.00 Its Depreciated Value, being somewhat newer than the other structures is estimated to be ..... \$ 1,500.00

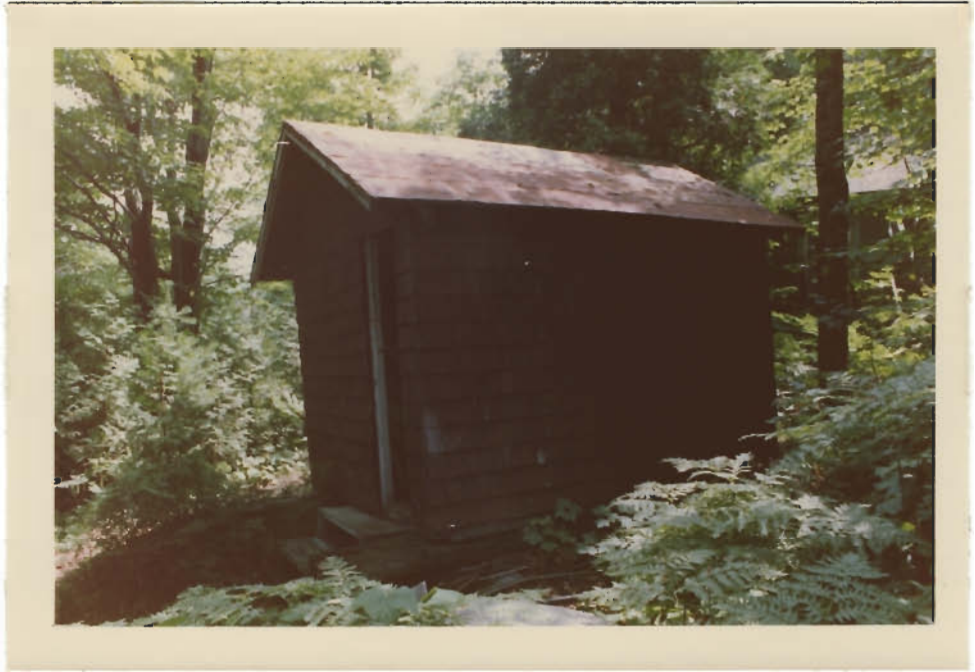
Pump house.

This building as seen on page 7, is about the same size as the office, but is in relatively poor shape and not well maintained. It has a Replacement Value of ..... \$ 700.00 A Depreciated Value of..... \$ 300.00
